SEAT PAN LOADING DIFFERENCES USING A NEW TEST APPARATUS

Paper Number 13-0102

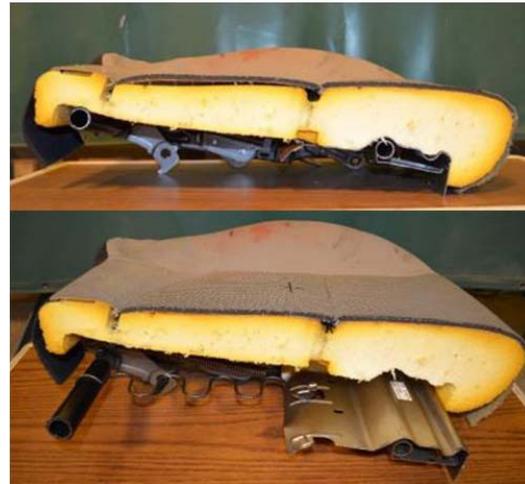
Photo 3. Cross-section of typical car seat construction. Under fabric upholstery and cushion is sheet metal cover on front of seat (to right) and a portion wire spring suspension is shown. Two side pieces are connected by a round tube in the rear and a second tube toward the front under the front cover.

The two sides were fastened together with a tubular member across the back and a front structure consisting of another tube and/or other structure. A wire upholstery spring suspension was used to suspend the rear of the seat by clipping onto the rear tubular cross-member. At the front of all the seats a stamped sheet metal cover fastened over the front cross-member and springs (Photo 3).

Rather than the single steel tube connecting the two sides under the front cover sheet metal, Model 3 seat also had a considerably more rigid stamped sheet metal member fastened between the two sides. It used a closed section welded sheet metal beam of thicker (1.4 mm) construction connecting the two sides beneath the upper cover. Model 3 was more than twice as stiff as the Model 1 shown in Photo 3.

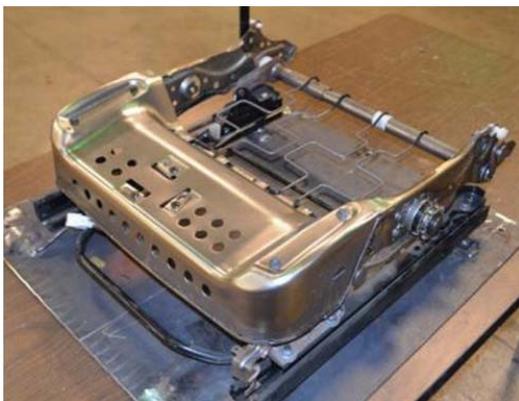
Photo 4. Model 1 structure. Sheet metal front cover over front frame tube wire seat suspension springs wrapped around rear tube.

The higher stiffness seats were constructed with more and heavier bracing between the side rail framework in the forward third of the seats. For instance, while Model 1 utilized a thin (0.67 mm thick) stamped steel forward cover and a 25 mm diameter tubular cross-tube beneath the cover, the cover was fastened to the side structures by four relatively small mechanical fasteners. Conversely, Model 3 was constructed with a thicker (1.0 mm) front upper metal cover over the top front corner of the seat frame that was welded to the side frames

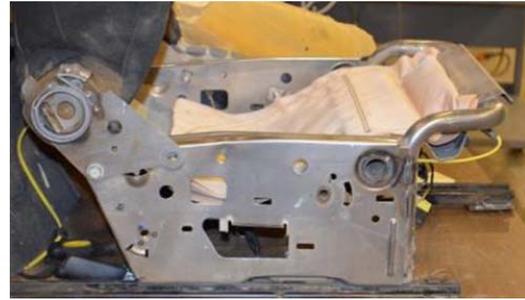
Photo 5. Model 5 seat. Sheet metal sides incorporating three cross-tubes.

In addition to the normal seat components, Seats 4 and 5 also were equipped with seat cushion airbags. Neither seat bolster bag was deployed before or during the testing. While the Model 4 used a wire spring suspension system Model 5 used a considerably different approach (Photo 5).

The side members of the seat were larger and taller than the other seats. Front and rear cross-tubes connected the two sides. In addition, a tubular frame rose from the floor level, up the front of the seat side frames, bent forward to extend the front of the seat, then laterally to form a rigid frame around the front of the seat. Rather than springs, a sheet metal pan spanned from the front tubular structure, rearward over the front tube, down to form a depression for the seat, then back to the rear tube (Photo 6). The pan was not attached to the sides but was welded to all three tubes. The airbag lay on top of the pan, under the cushion.

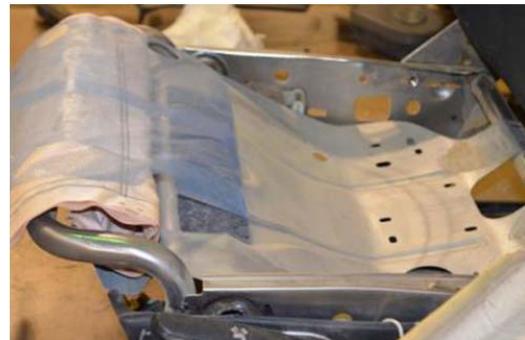
Photo 6. Airbag folded forward to show seat pan.
