**Re: Spinal Compression Testing**  
**(Our Project Reference: P13-019)**

## Static Seat Testing Report

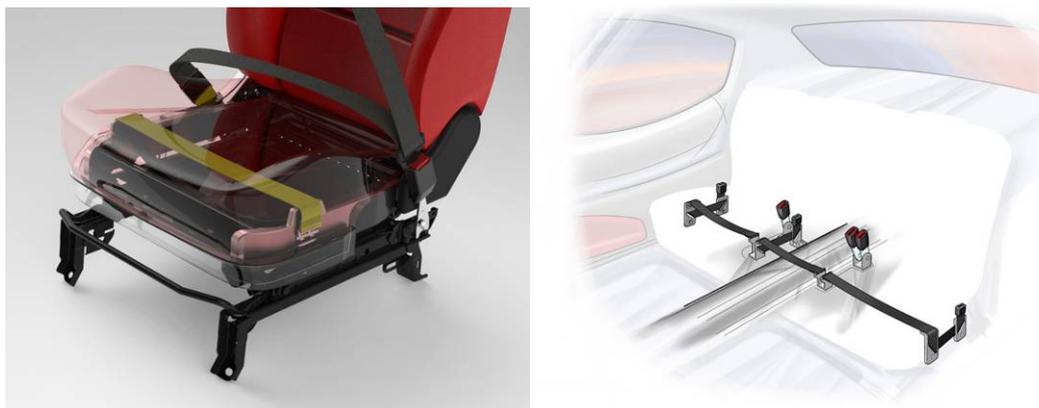
**Figure 2 Lifebelt device concept**

The aim of the testing was to compare two current production anti-submarining seat pan structures, one front and one rear seat, to a modified seat structure fitted with the Lifebelt restraint system. The Lifebelt restraint system is a patented design which includes an extension of the existing seat belt webbing in a continuous loop around the upper thighs (i.e. within the seat structure and cushion). The device has undergone proof of concept

testing (Gibson et al., 2011<sup>2</sup>), demonstrating that it is an effective anti-submarining restraint system for both front and rear seat occupants. The device concept is pictured in Figure 2 below.

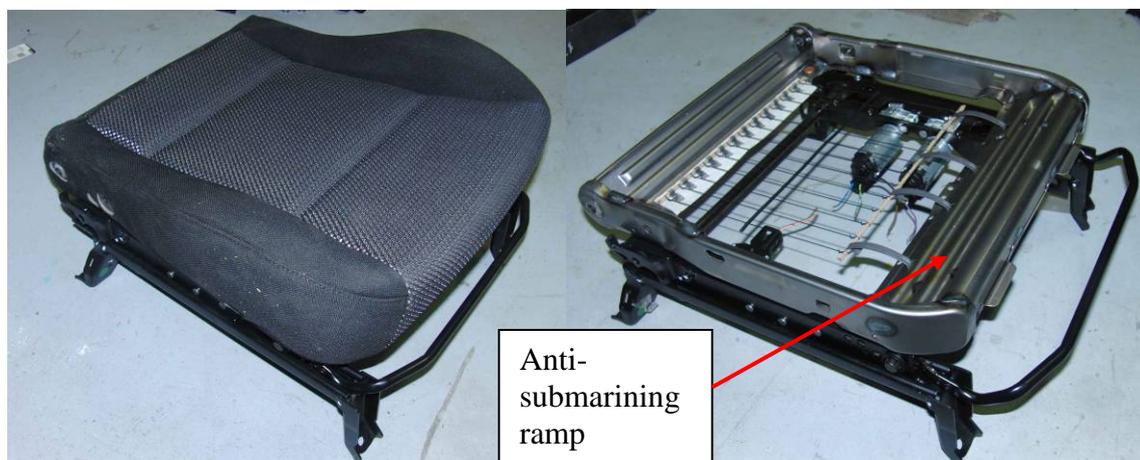
**Figure 3 Standard front seat base.**

Two standard front seat bases from a current model vehicle were tested as a control, see Figure 3. The test seat bases were mounted with the seat rail horizontal. The structure of the seat base underlying the cushion is pictured in Figure 3.

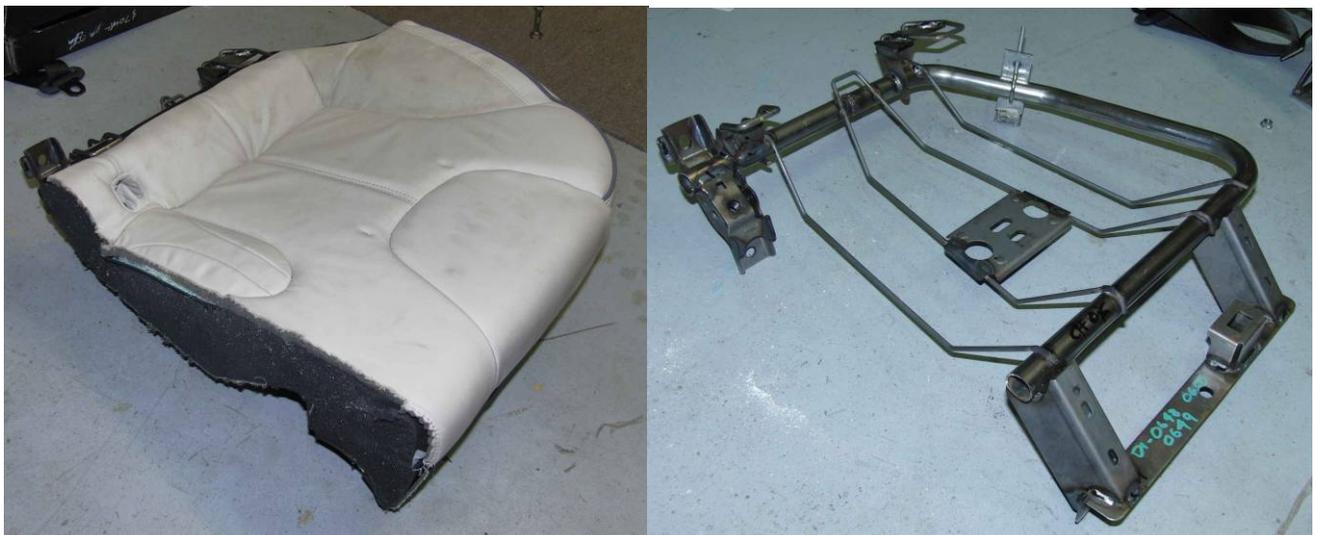
**Figure 5 The standard left passenger rear seat, showing the underlying structure.**

Two left hand sections of a current model vehicle rear passenger seat bases were tested. The standard seat base was tested first. The seat and the structure underlying the cushion are shown in Figure 5. The seat bases were both tested at the same angle used for the earlier sled test series.
